R D.Oldham

Memoirs, Vol XXIX Frontispiece

MEMOIRS

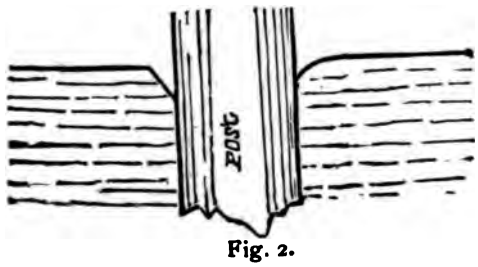
Fig. 2.

"The houses of the Deputy Commissioner, District Superintendent of Police, Forest Officer, and Sub-Engineer are damaged more or less severely in the same fashion. Several posts have sunk from a few inches to a foot deeper into the earth, causing the floor to buckle and the roof to sag. Many, too, are out of the perpendicular. At the point each post enters the ground, a cup-shaped depression, from one to six inches in depth and diameter, has been worn round it thus (Fig. 2) as though the post had been given a circular movement :

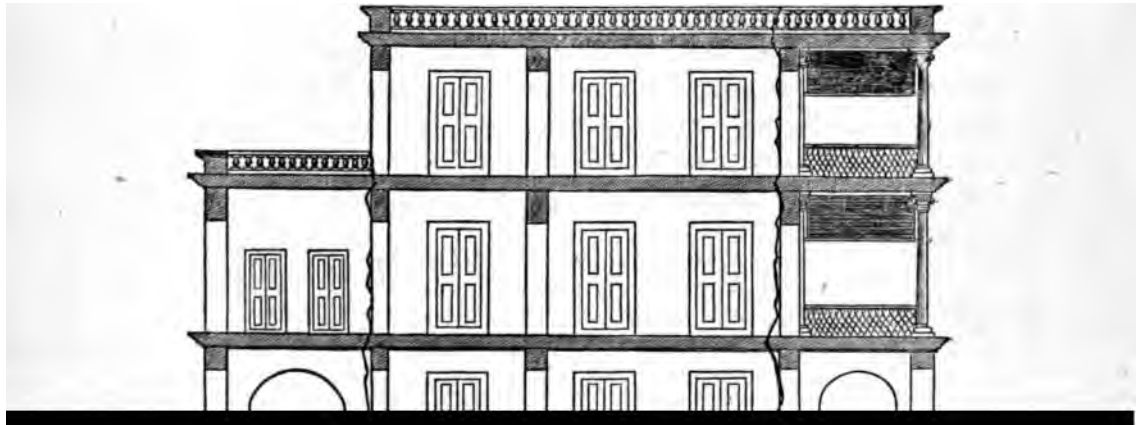
Figure 3 represents the transverse section of a typical Calcutta house. There is a central portion built with thick walls, with flat cemented roof and cemented or marble floors to each story; on the south is a broad verandah, where the roof and floors are carried by

From this description it will be seen that the house is divided by two vertical planes into three very distinct portions of very different weights and proportions. Consequently when the house is set rocking each portion will try to swing as an inverted pendulum, with its own proper period of oscillation. As this will be different in each case, and as the difference is greatest in the case of the main body of the building and the south verandah, the different portions, unless strongly tied together, will alternately separate and press upon each other.

After the earthquake it was found that by far the greater amount of the serious damage done was of the character described, and few were the houses, even those otherwise little injured, where two cracks did not open as shown in fig. 3. Moreover, it was found that where the main beams supporting the roof and floors ran north and south, in the same direction as those of the verandah, and hence acted in some degree as ties, the damage was much less than when the beams in the main building ran east and west and those in the verandah north and south.

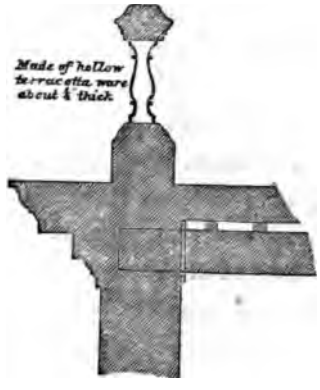
Fig. 4. Section of roof, cornice, and parapet of a private house, Calcutta.

Another cause of the damage in Calcutta was the heavy and weak balustrades and cornices found on most of the older houses. These will be noticed in the views reproduced on Plates XXIII and XXIV,

and are represented in section on figures 4 and 5, for which I am indebted to the courtesy of Messrs. Macintosh, Burn and Co. Figure 4 represents in section the roof, cornice and balustrade of an ordinary private house; fig. 5, that of the Calcutta Town Hall, which may be regarded as an extreme case of this type of construction. The balustrade, whose general appearance can be seen on Plates XXIII and

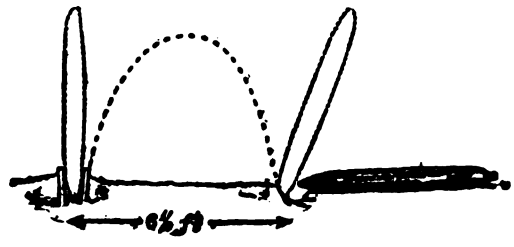
Fig. 14. Disturbance of Khasia monuments near Rambrai.

had been destroyed, not by breaking off, nor by upsetting, but by being shot upwards out of the ground as indicated in fig. 14. One of these had travelled 6½ ft. through the air from the place where it had stood to the place where a deep dent marked the spot at which its lower end had first struck ground. The socket in which its base had been buried was almost uninjured, and the angle at which it was shot upwards could not have been much, if at all, less than 60° with the horizon.

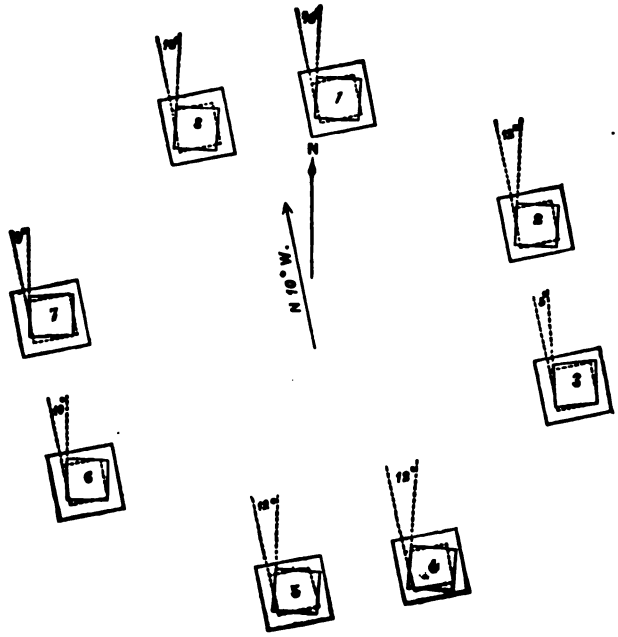
Fig. 24. Plan of pillars of thermometer shed at Dhubri.

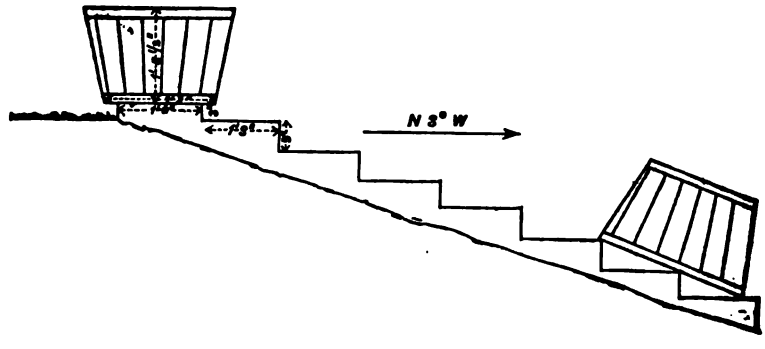
Fig. 25. Overthrow of plant-tubs at the Assistant Commissioner's bungalow, Goalpara.

The bungalow itself has entirely fallen, the general direction of fall being towards north. In front of it is a flight of steps eight in number (see fig. 25), on the topmost of which stood two tubs, one at each side, filled with earth. Both of these have toppled over and rolled down the steps, both falling in exactly the same direction, to N 3° W. They seem to have struck the third step from the top in falling and then turned completely over. It is possible that the tubs were jerked forward to the edge of the steps by the shock and then tilted over. If they were first tilted up, it would, I found by trial, require an angle of tilt of 35° to cause the tub to slip off the edge of the step.[1]

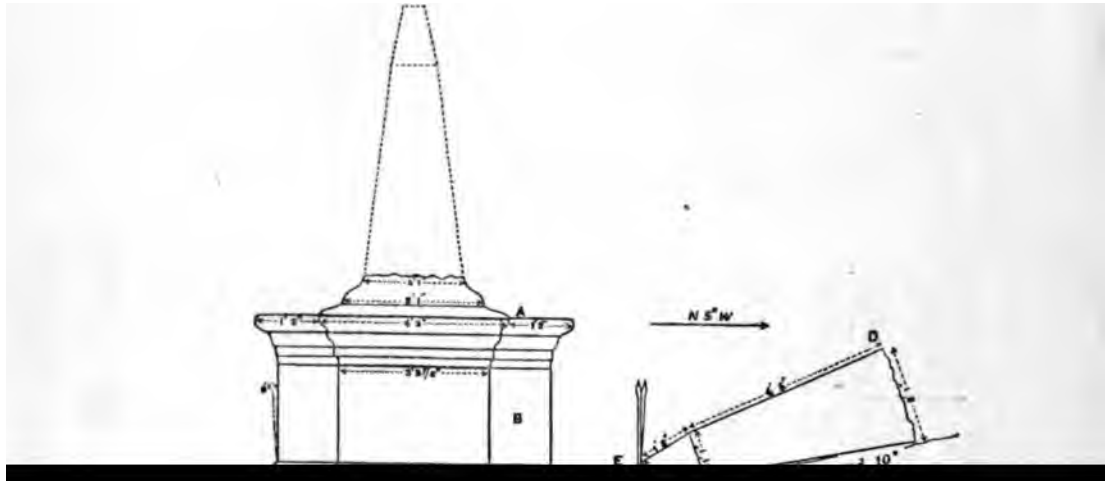
Cemetery. Tomb of Mrs. Ann Simons.

The cemetery is situated on the south-south-east slope of the ridge, the average angle of slope being 15°. The monuments are mostly of the oblong box form, common some 50 years ago, with their longer axes lying east to west, or transverse to the slope of the hill. Mrs. Simons' tomb has fallen over to S 5° E without breaking, and now stands at an angle of 24° from the vertical.

turned over, since the apex is now lying at the foot of the railings surrounding the tomb. It just touched the top of one of the spikes of the railings in falling and bent it slightly outwards.

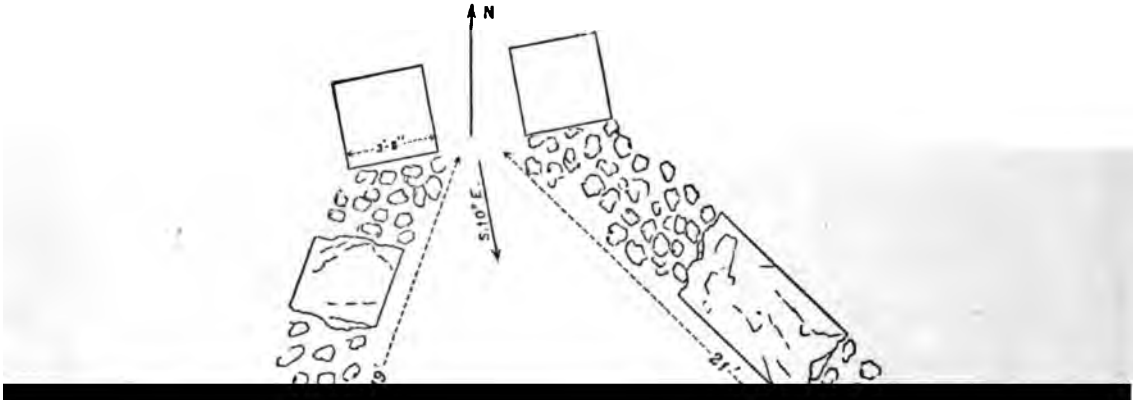
David Scott's monument.

53. **Cherapunji.** The monument erected by the Supreme Government to the memory of David Scott is a very massive structure, built of large squared blocks of sandstone, bound to each other with iron clamps. The upper portion of the obelisk has fallen, mainly towards the S W, but some portion has also fallen towards N N E. One of the loosened stones is still lying on the top, overhanging the southern side by about ⅓ of its length. The whole monument above the two steps at the base has moved bodily towards S W. The stones of the lowest course of the pedestal have been shaken apart from each other, the one on the west side having been jerked out to the edge of the step below.

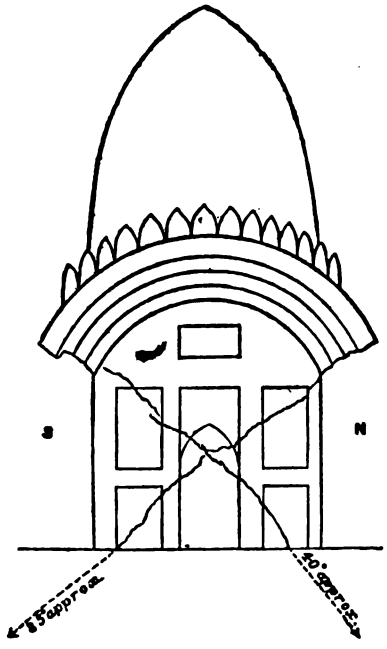
Fig. 30. Hindu Temple in cantonments, Sylhet.

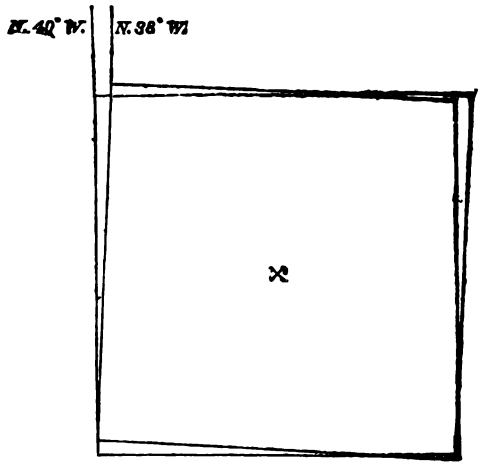
Fig. 31. Plan of twisting of obelisk in the Cemetery at Darjiling.

At Darjiling we have the tomb described by Mr. Hayden (Appendix A) and represented on Plate XXXII, fig. 1, the plan at the plane of twisting being shown in fig. 31. The orientation of this was E 40° N; it was twisted *positively* 2°, and the centre shifted $\frac{1}{2}$ in. to E 40° N. The section at the plane of twisting was 1 ft. 6$\frac{1}{2}$ in. square.

In the European Cemetery on the western side of the hill, below the Shrubbery an obelisk has been affected in a very interesting manner. At the plane of junction between two of the stones, the plaster has given way, and the upper portion of the obelisk has been disturbed in such a manner that it has apparently been twisted through an angle of about 2°: as shown in plan in figure 31. The monument is built of sandstone, of which a small chip gave a specific gravity of 2·485; this gives a weight of 12½ cwt. for the upper part of the monument.

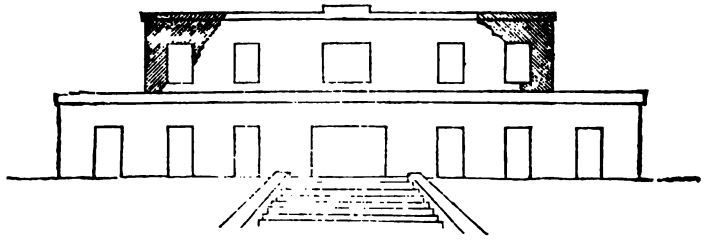
Fig. 38. Railway Station at Tinpahar.

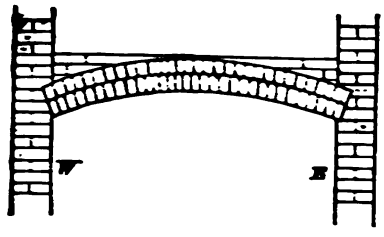
Fig 39. Flooring in Nawab's Palace, Murshidabad.

In the Nawab's new palace nothing has been left standing but the outer walls. This building, which is made of bricks, faces the west, and has an upper story; there were no wooden or iron beams: the ceilings consisted of shallow arches.

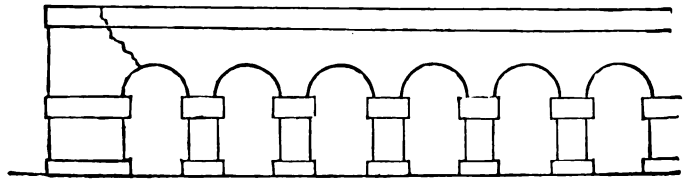
Fig. 40. Elevation of buildings at Berhampur.

On the other hand, rows of arches like those in some of the public buildings at Berhampur (Fig. 40) have stood very well, whatever position they may have occupied with respect to the direction of the shock, and notwithstanding that the transverse beams they support have often displaced them from the vertical to a

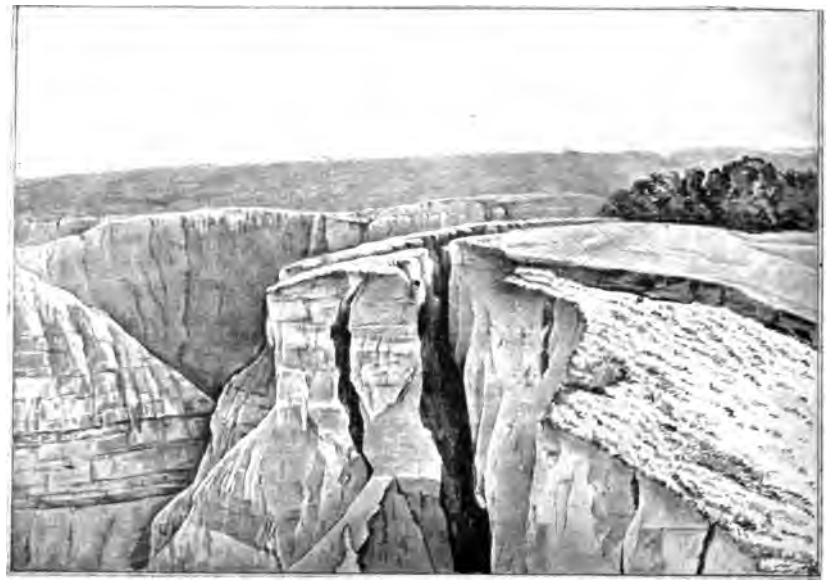
FIG. 1. FISSURES IN SANDSTONE AT EDGE OF THE BÁLPAKRÁM PLATEAU, GARO HILLS.

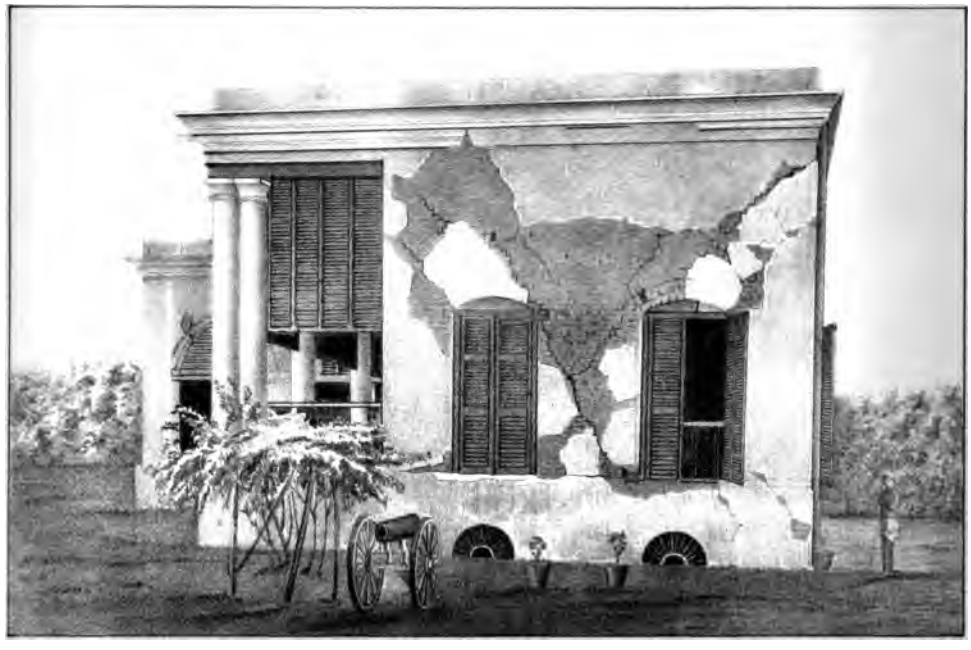
FIG. 2. MANAGER'S BUNGALOW JUTE MILL, SERAJGUNJ.

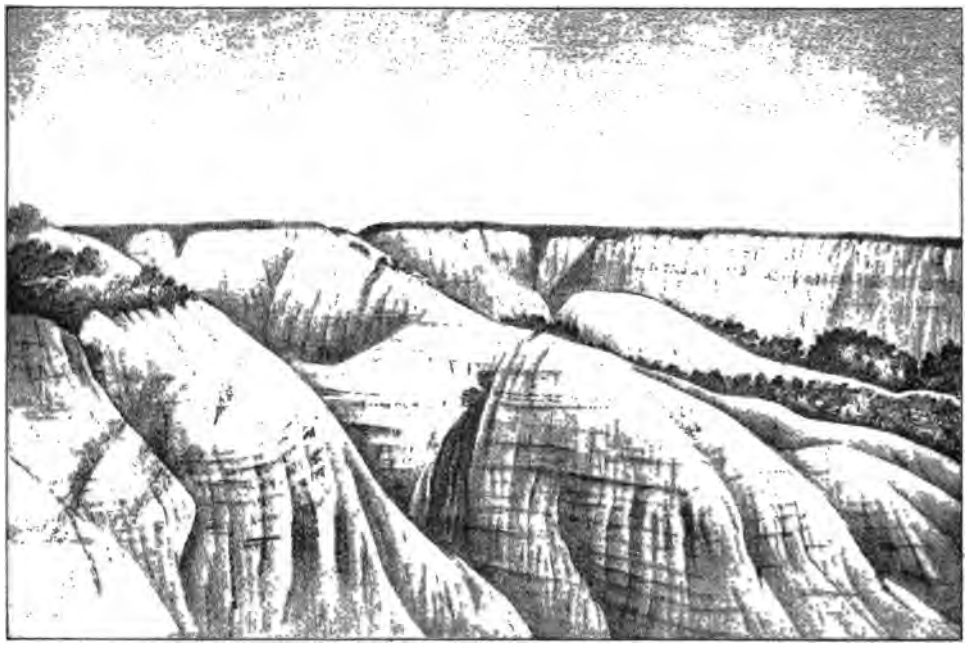
FIG. 2. LANDSLIPS IN MAHADEO VALLEY, GARO HILLS.

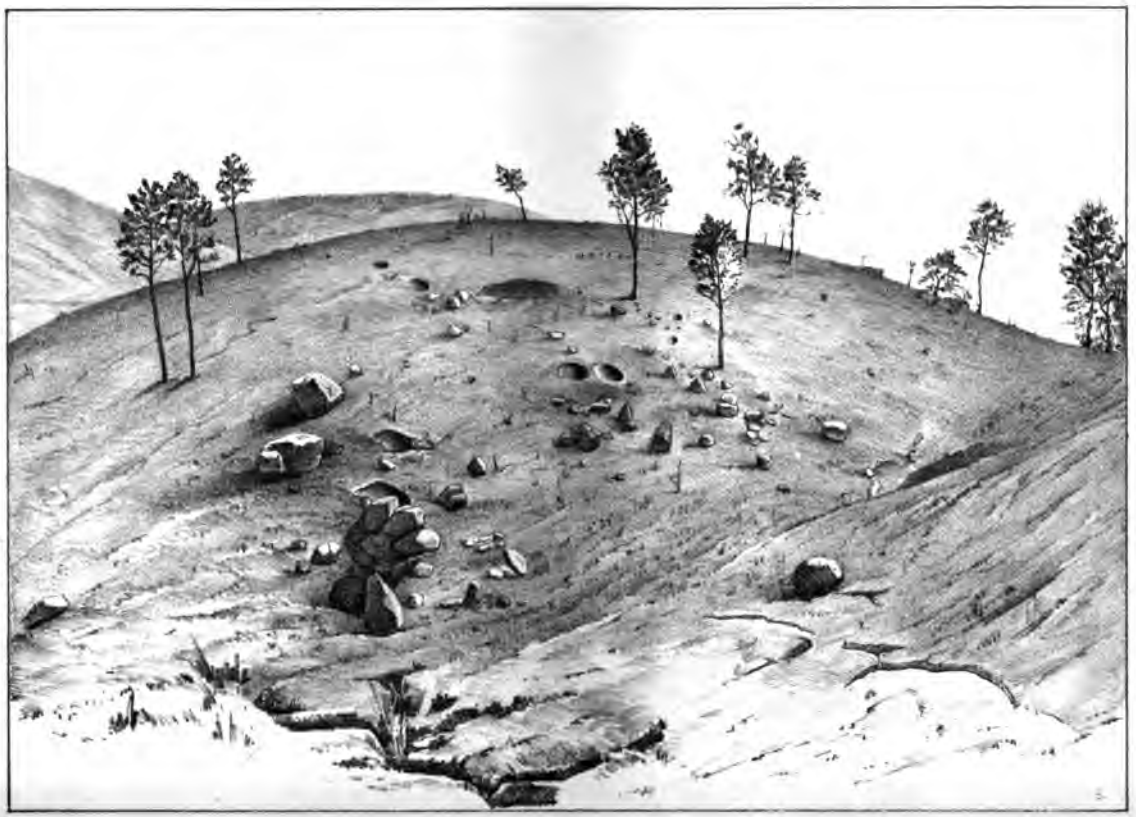
DISPLACED BOULDERS NEAR KANCHI, KHASI HILLS.

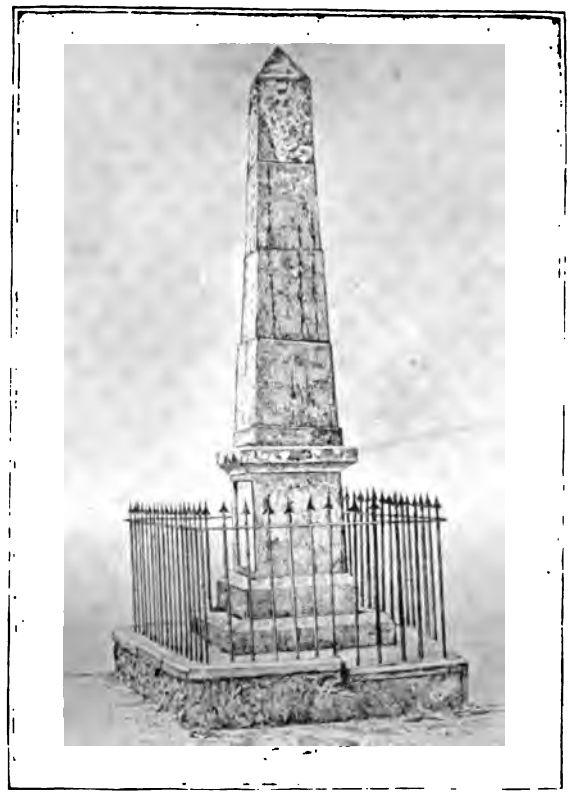
FIG. 1. TOMB IN DARJILING CEMETERY.
(Top part twisted.

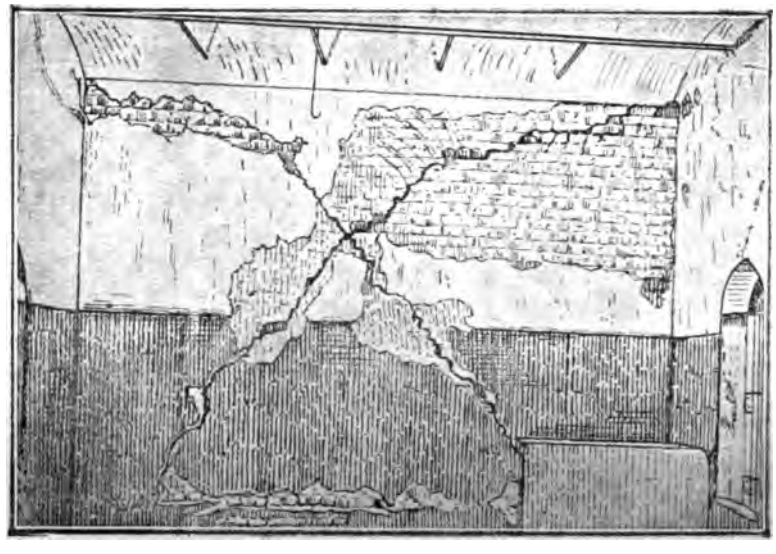
FIG. 2. CRACKS IN WALL OF JAIL, MAIMANSINGH.

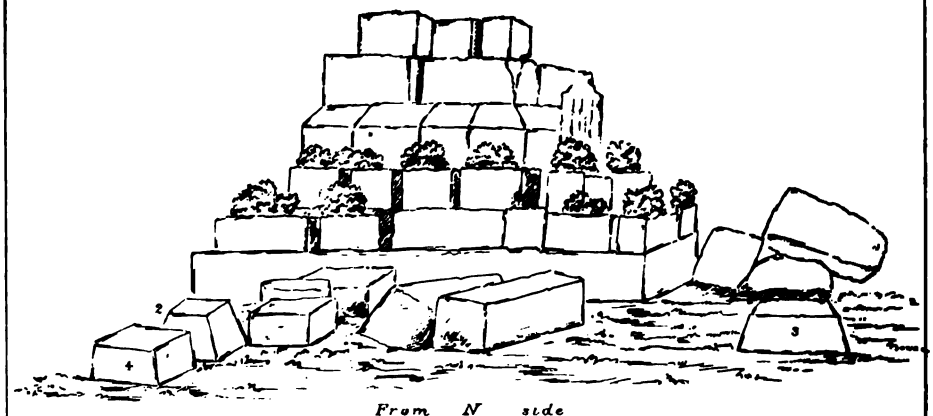
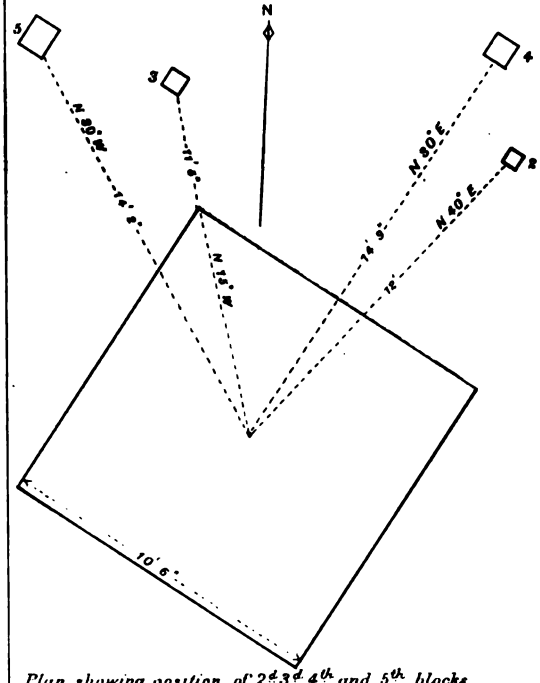
WILLANS MEMORIAL, SHILLONG.

Plan showing position of 2d 3d 4th and 5th blocks from top of obelisk

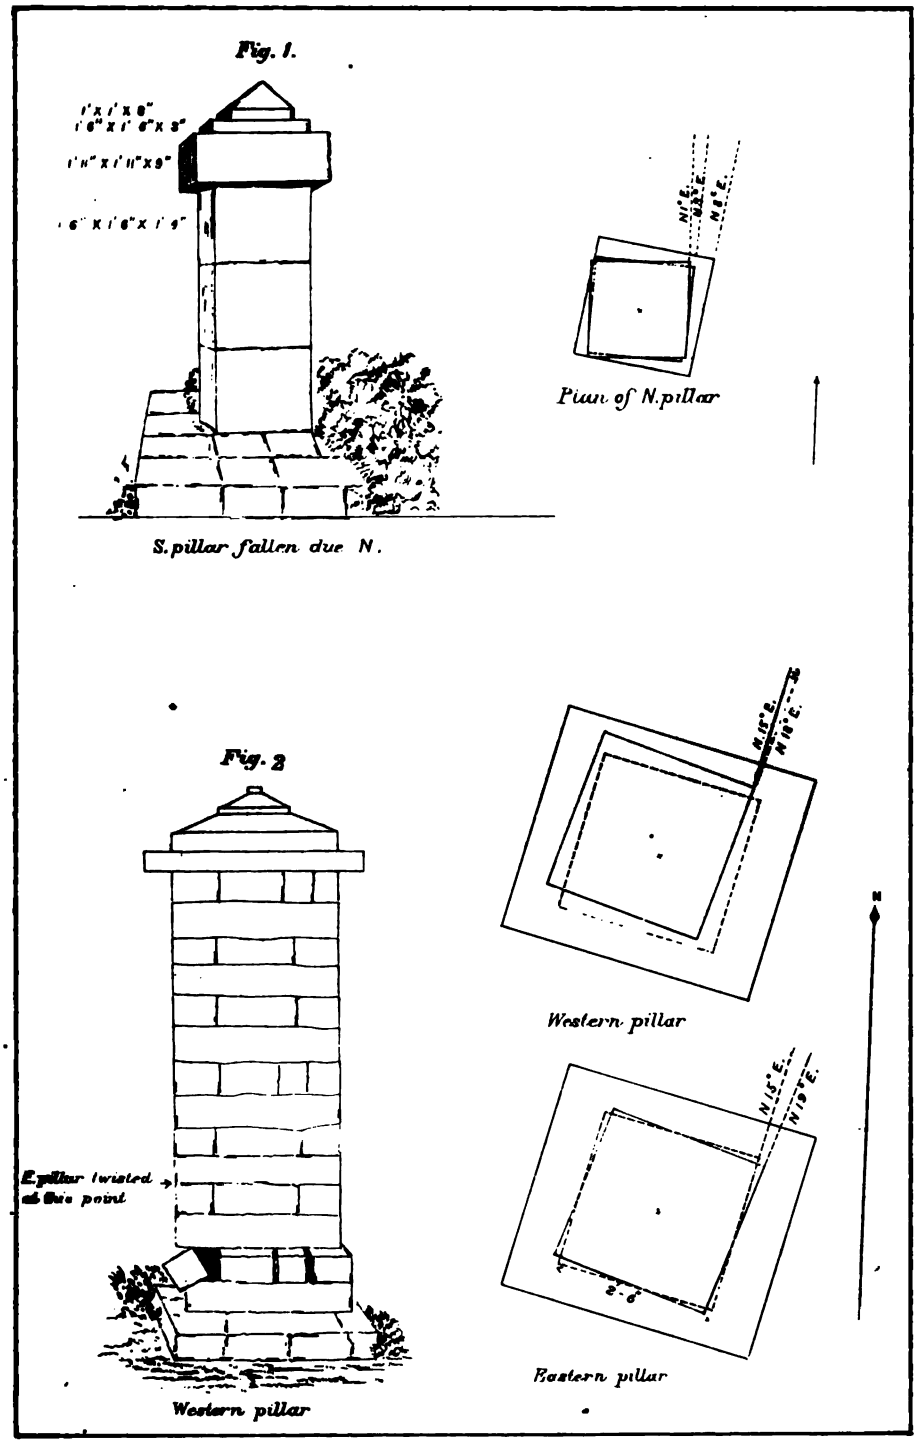
TWISTED GATE PILLARS, SHILLONG.

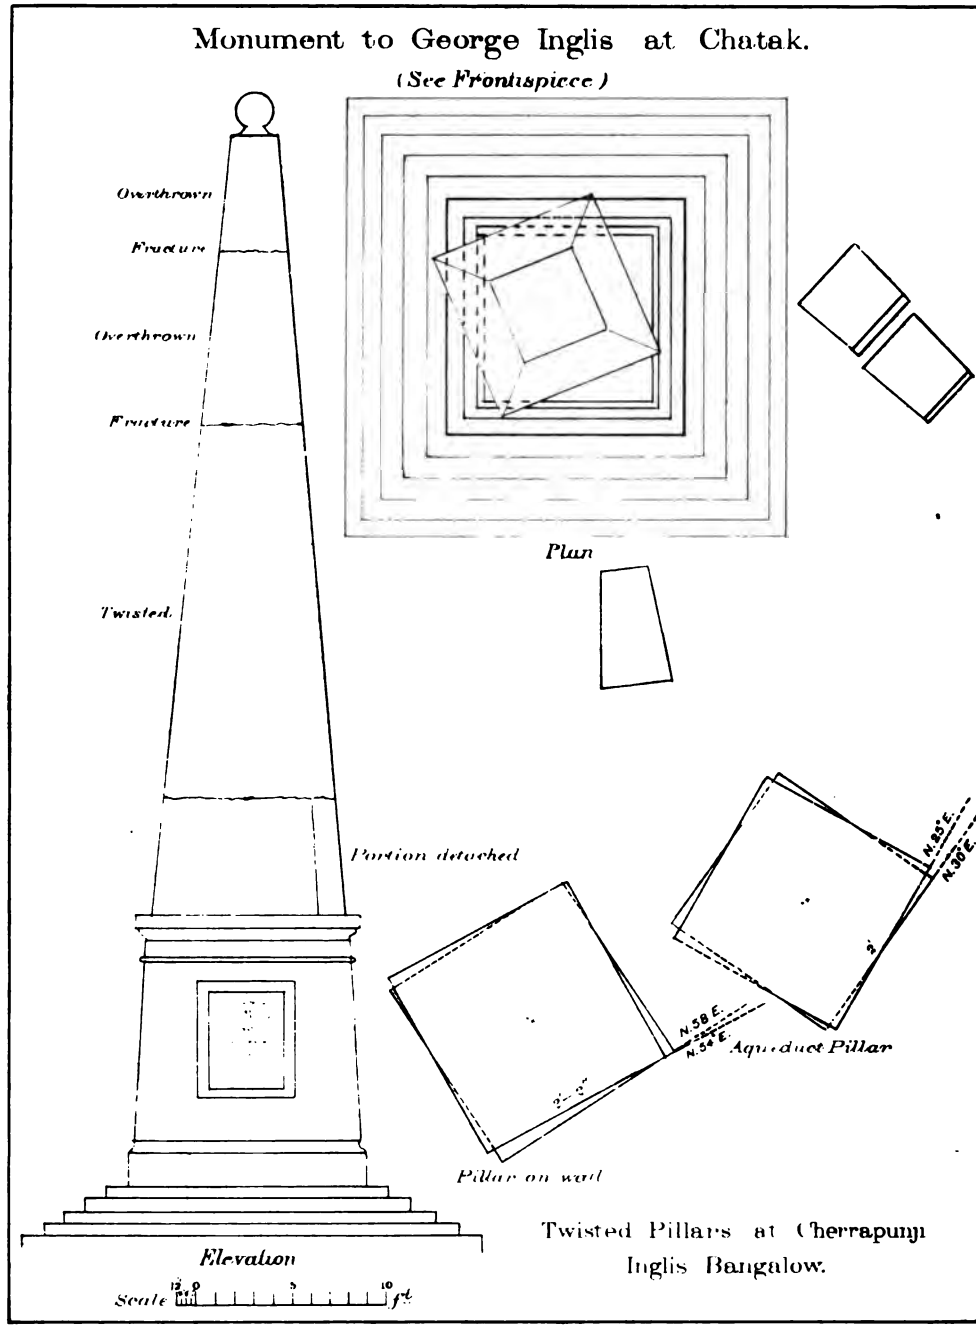
TWISTED PILLARS AT CHATAK AND CHERRAPUNJI.
